HOOPER BAY AIRPORT

2004 Alaska Airport Pavement Condition Report

HOOPER BAY AIRPORT - 2004

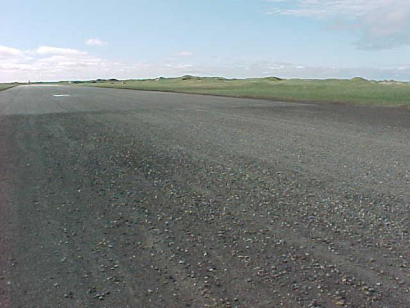
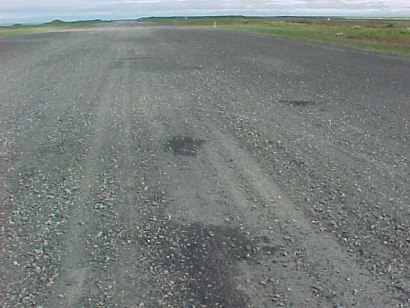
- Airport Class: Non-Primary
- Last pavement condition survey: 2002
- Next planned pavement condition survey: 2005
- 2004 reported pavement maintenance and/or changed conditions: The center of the runway (Section 6100-02) is failed and reverted to gravel. Crack sealing and cold mix patching were done on other paved areas. A storm washed seawater onto the runway in October. See photos.

- **Recommendations:** Complete reconstruction or relocation.
